Steam Schooner
WAPAMA
HISTORIC STRUCTURE REPORT
1986

Steam Schooner
WAPAMA
HISTORIC STRUCTURE REPORT

**The National Maritime Museum at San Francisco
The National Park Service,
Golden Gate National Recreation Area
Fort Mason, Building 201
San Francisco, California, 94123**

**Tri-Coastal Marine, Inc.
(White Elephant Management)
2104 Strand, Galveston, Texas, 77550**

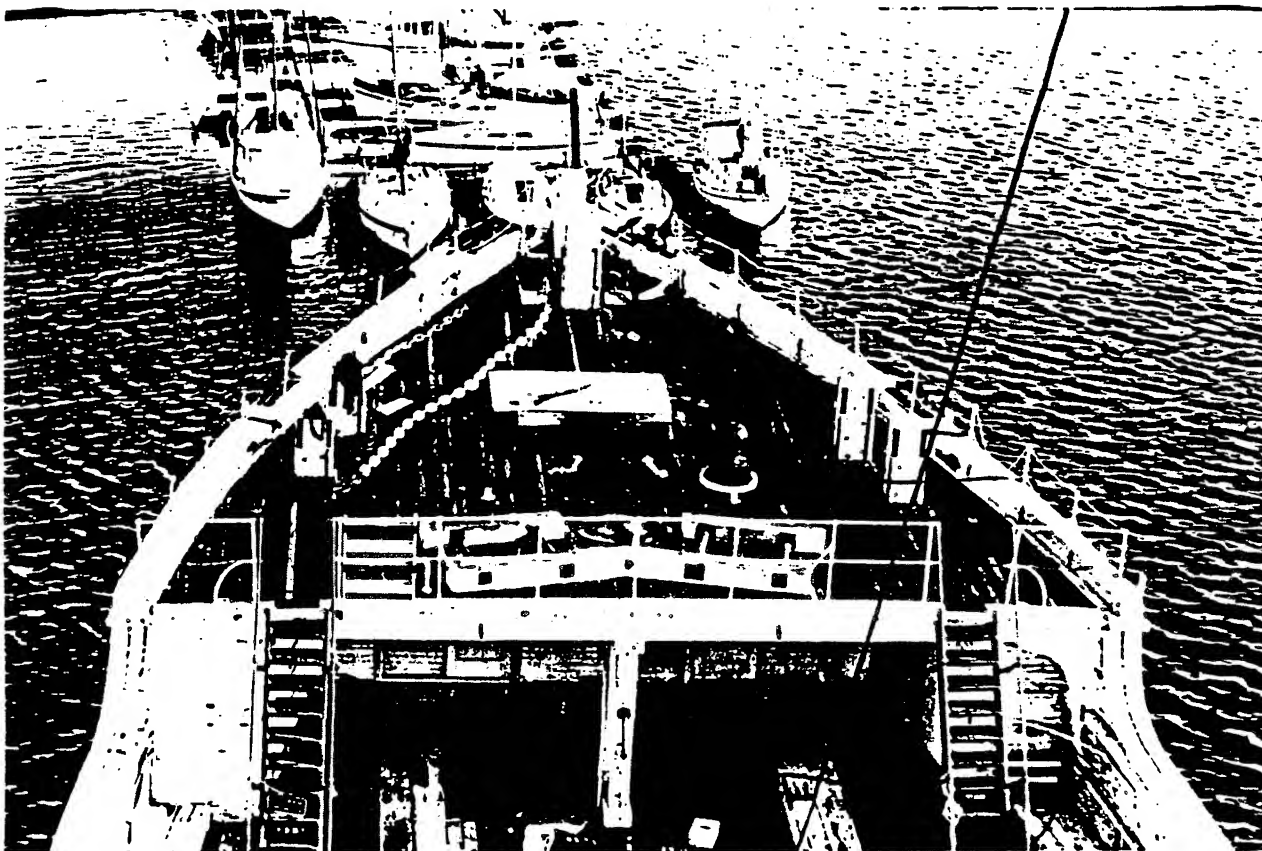
In order to achieve even the modest goal of public access, the forecastle head deck would have to be rebuilt, including replacement of deck beams, clamps, planking, bulwarks and covering boards. Remounting of the mast and deck gear would require additional work to further support the forebody. Alternately, this deck could be preserved as is by extending weather protection and treating existing rot, though public access would have to be limited.

Fig. 10. View of forecastle head deck. Sliding doors to forecastle are visible under overhanging after end of deck. Note winch foundations at after end of deck. This deck is now covered by a roof structure. --Photo, TCM

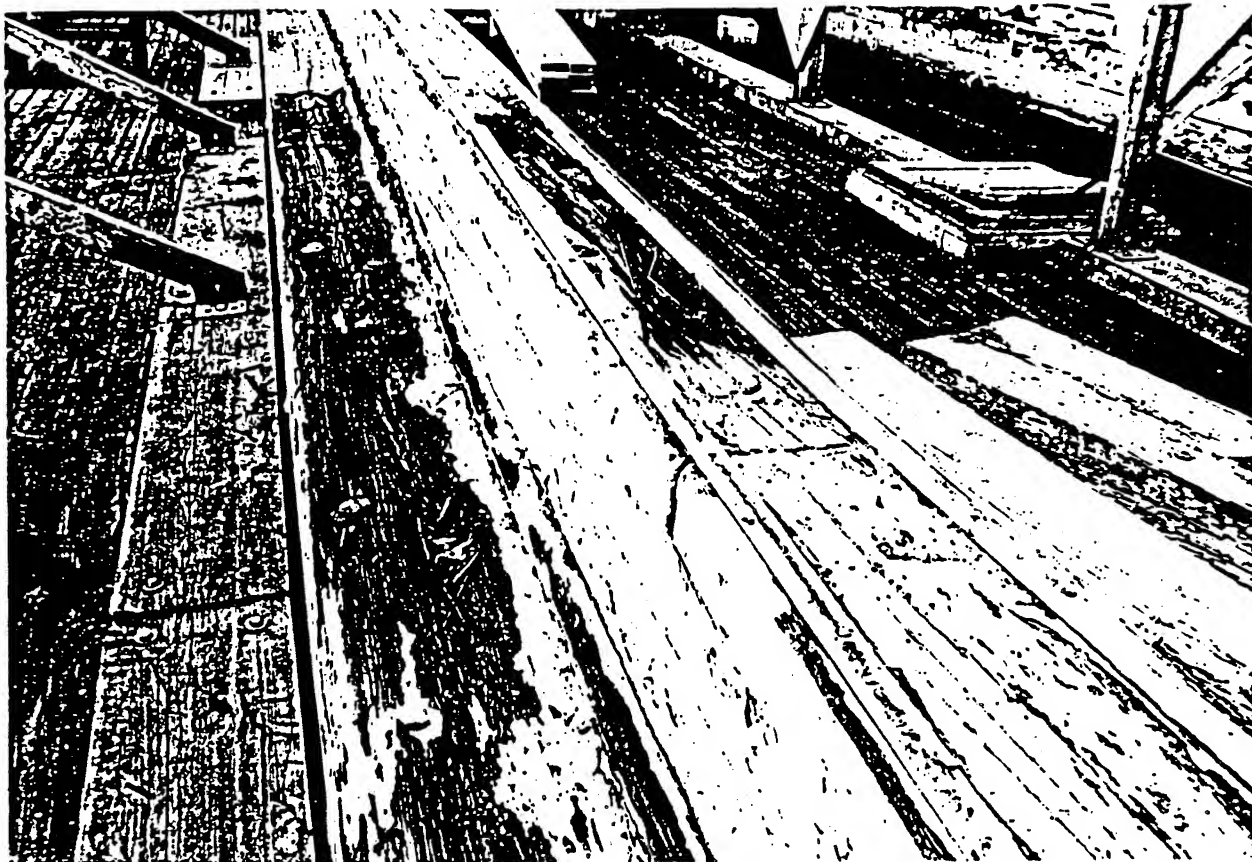
Fig. 12. View of main deck, port side, showing deck stringer and side stringer, area of severe rot localized around fastenings. Note former deck opening at samson post partners, upper right of photo. Beginning of main deck roof structure seen alongside side stringer. --Photo, TCM

An alternative preservation method would be renewal of all major members of the deck, as well as the deck planking. This would necessitate replacement of approximately 20 deck beams, as well as waterway timbers, deck girders and possibly some frame futtocks. The relative advantages of this alternative are discussed in section VI.D.6, Structural Renewals.

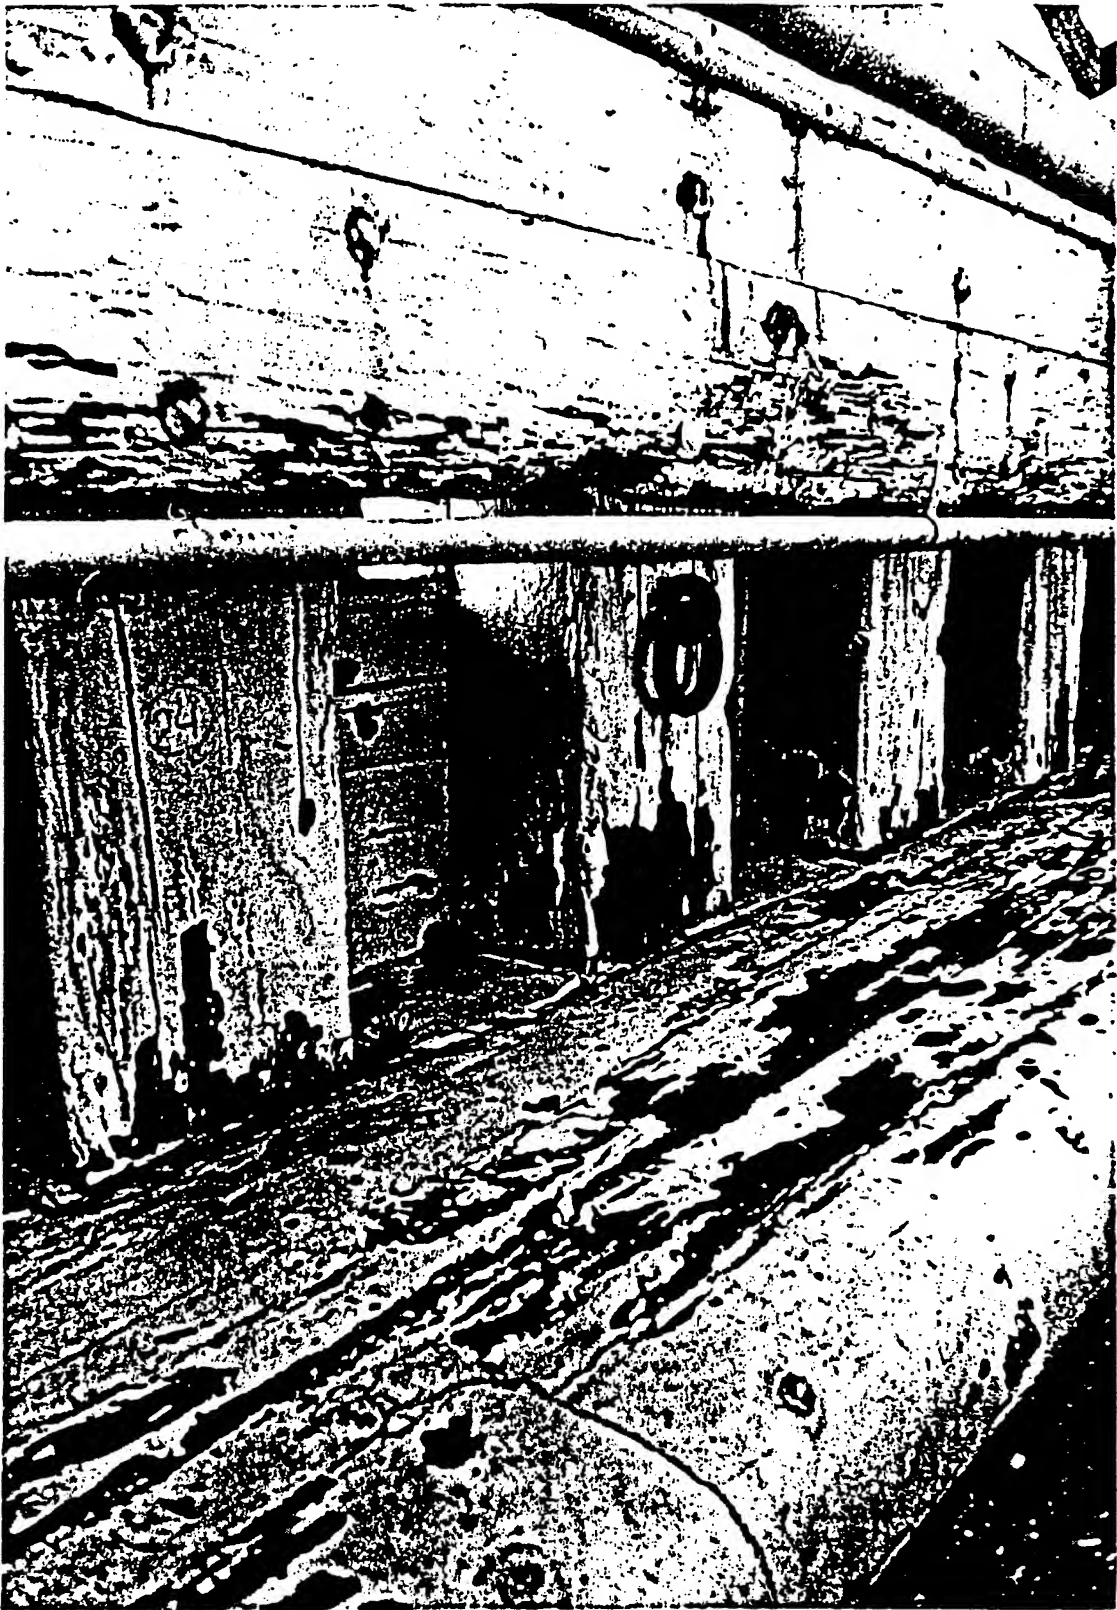
The bulwarks retain adequate strength to stay in place and are not a safety concern at this time. Extensive deterioration seen in the bulwark stanchions present a problem for interpretation. As in the early 1960s, these rotten timbers could be patched with cement or similar filler material, though this would be a stopgap measure and would do nothing to arrest ongoing rot. Any major rebuilding of the main deck should include renewal of at least some of the deteriorated stanchions. A rebuild of the bulwarks would necessitate loss of most of the weathered original fabric, such as the inwales, which are illustrative of the hard working life of the vessel.

Fig. 13. Deteriorated bulwark stanchions. Most severe rot is seen at the waterway timber, where moisture remains trapped.
--Photo, TCM

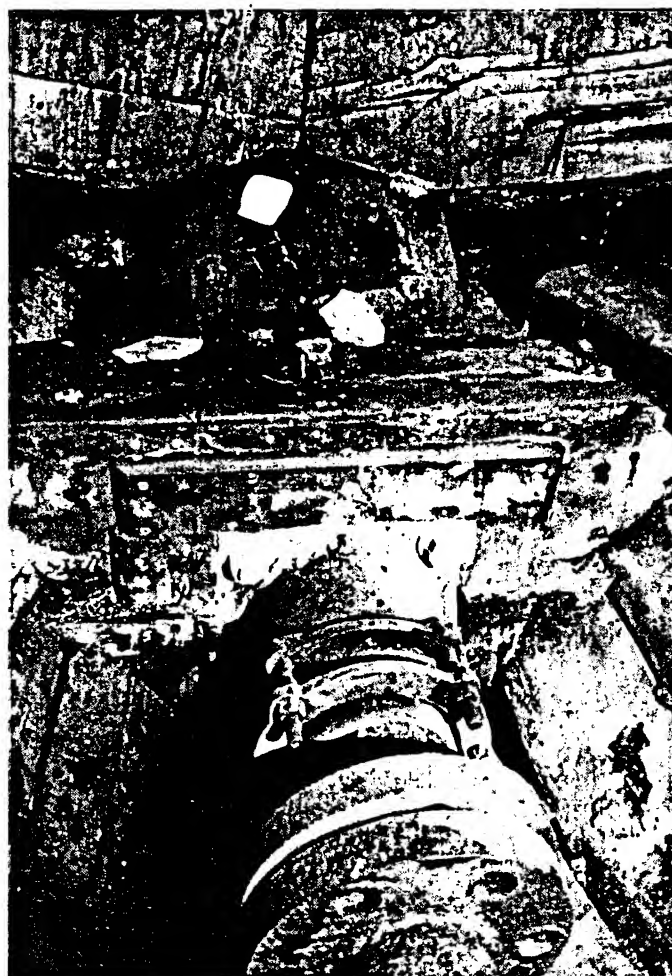
The afterpeak is, by design, not suitable for public access or viewing. Most of the deterioration seen in this compartment is old, though seepage through the main deck will eventually cause additional damage. A major concern in this area of WAPAMA is the movement seen in the stern section. Additional shoring will be needed under the counter in order to prevent further collapse of the structurally weakened stern. To help prevent further decay in the afterpeak, seepage should be stopped by repairing or covering leaking areas above. Forced air ventilation will also help to slow decay by moving stagnant air in this enclosed space.

Fig. 23. Afterpeak, looking aft; stuffing box and shaft coupling. Pointer butt is seen over horn timber at top of photo. Note offset in coupling due to hull distortion. --TCM

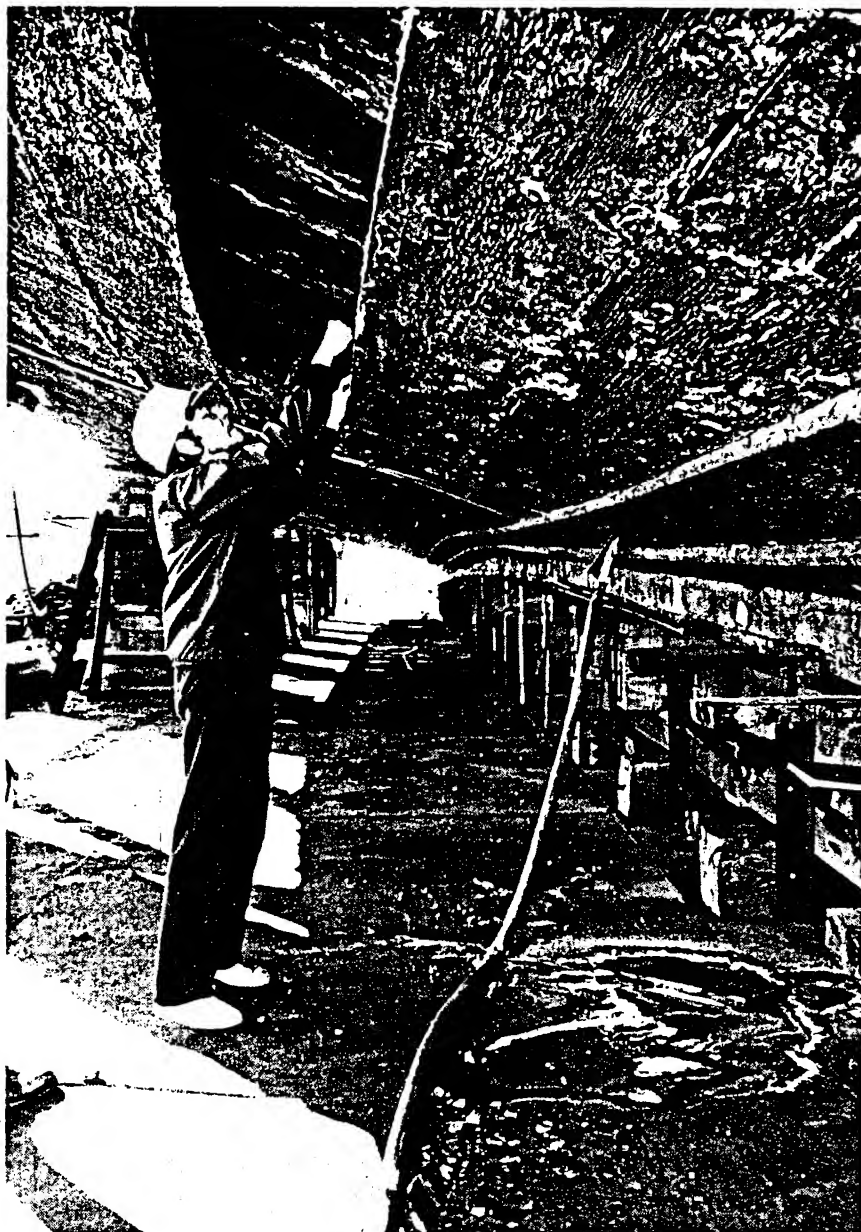
Approximately 40% to 50% of the iron spike plank fastenings show moderate nail sickness extending 1" to 2" around fastenings, and up to 3/4" deep. Most trunnels are still effective, though a few are seen to be partially decayed or abraded at the plank-to-frame faying surface.

Fig. 32. Bottom, stbd side, on barge, Nov, 1985. Double-sawn frames may be seen where planking has been removed (see Fig. 33). Note hog in keel. --Photo, TCM

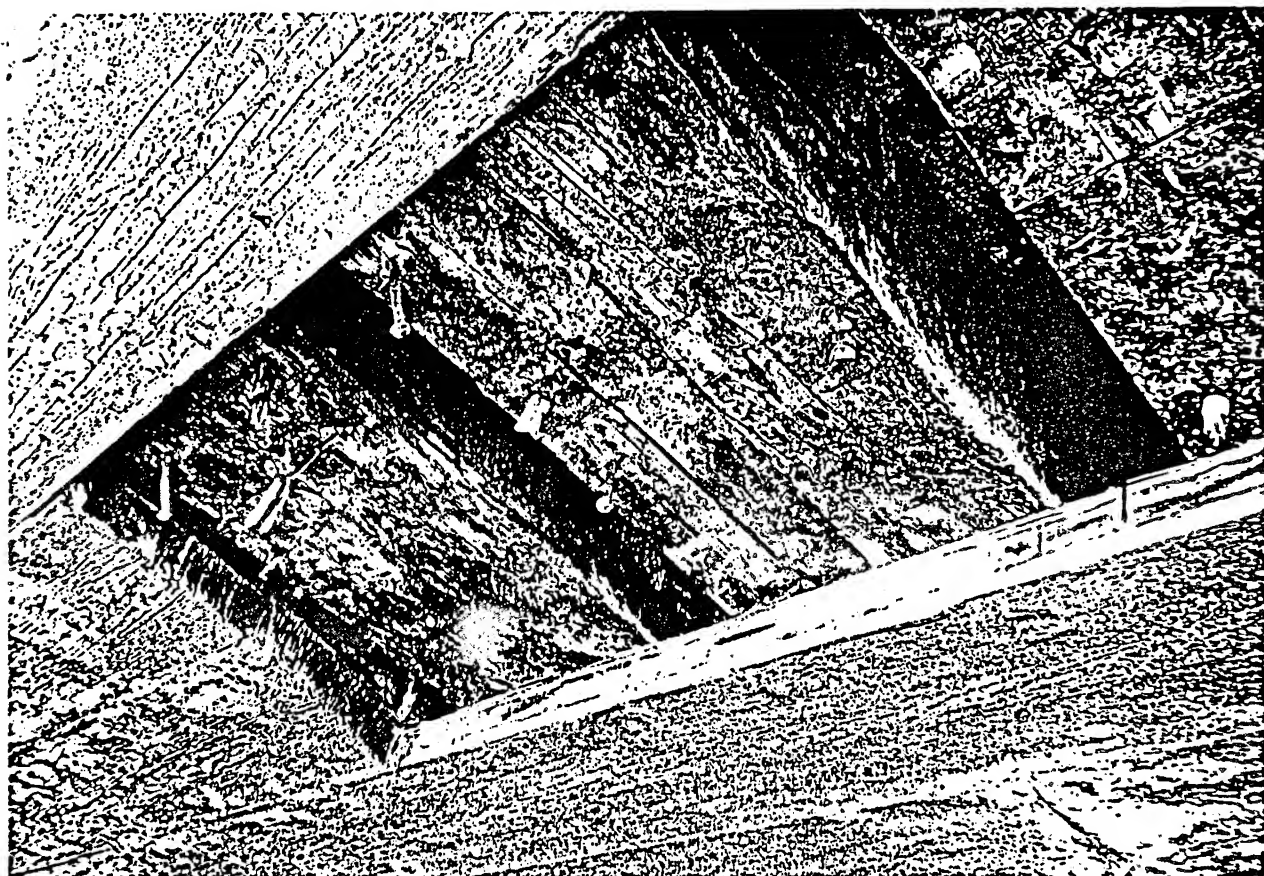
Fig. 33. Section of bottom planking removed for inspection during 1982 survey. Double-sawn frames can be seen with iron spikes and trunnels (wooden planking fasteners) projecting. --Photo, TCM

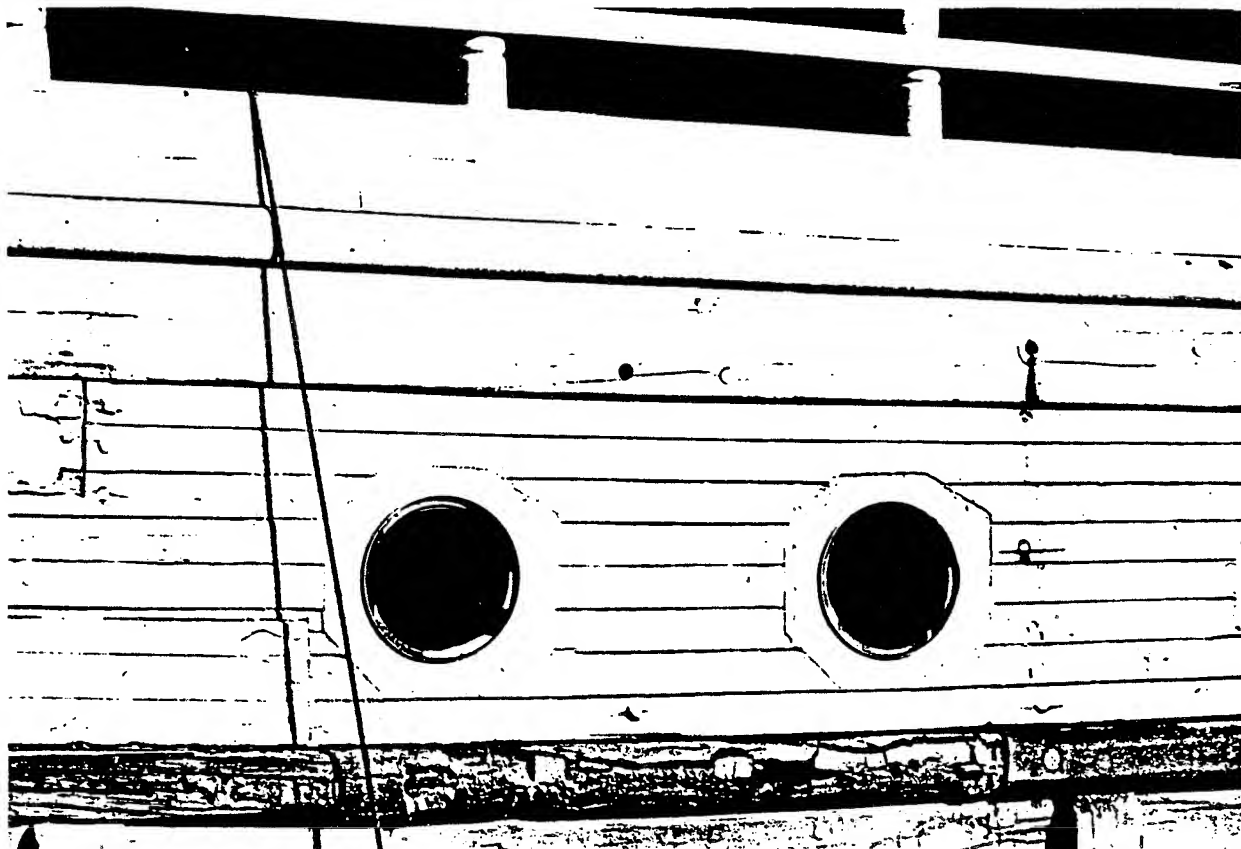
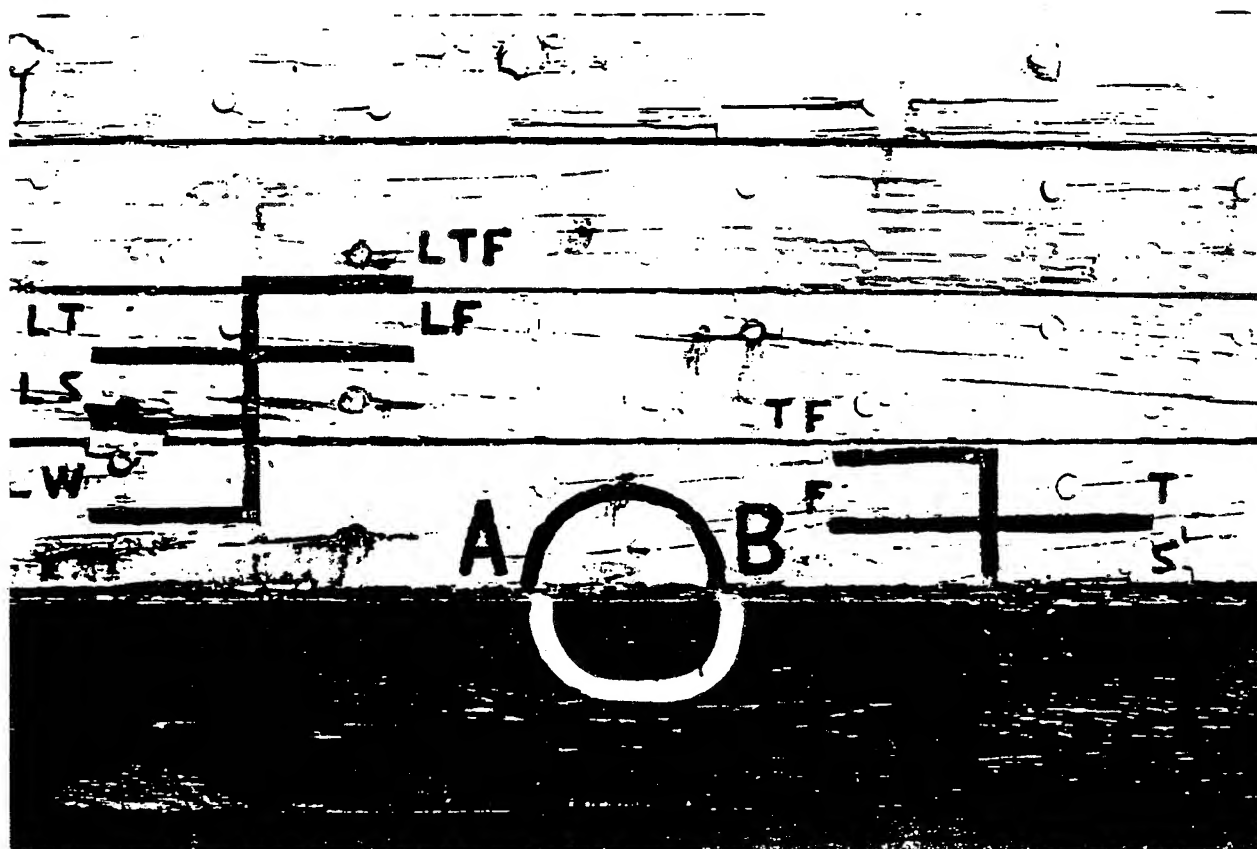
Fig. 34. View of starboard quarter showing decay in rubstrake. Fig. 35. (below) Topsides at midships. Note open seams in topside planking. --Photos, TCM

The hull is presently in need of additional support, particularly at the bow and stern. In the short term, this can take the form of additional wood shoring, though in the long term, interpretation would be best served by an engineered support system.

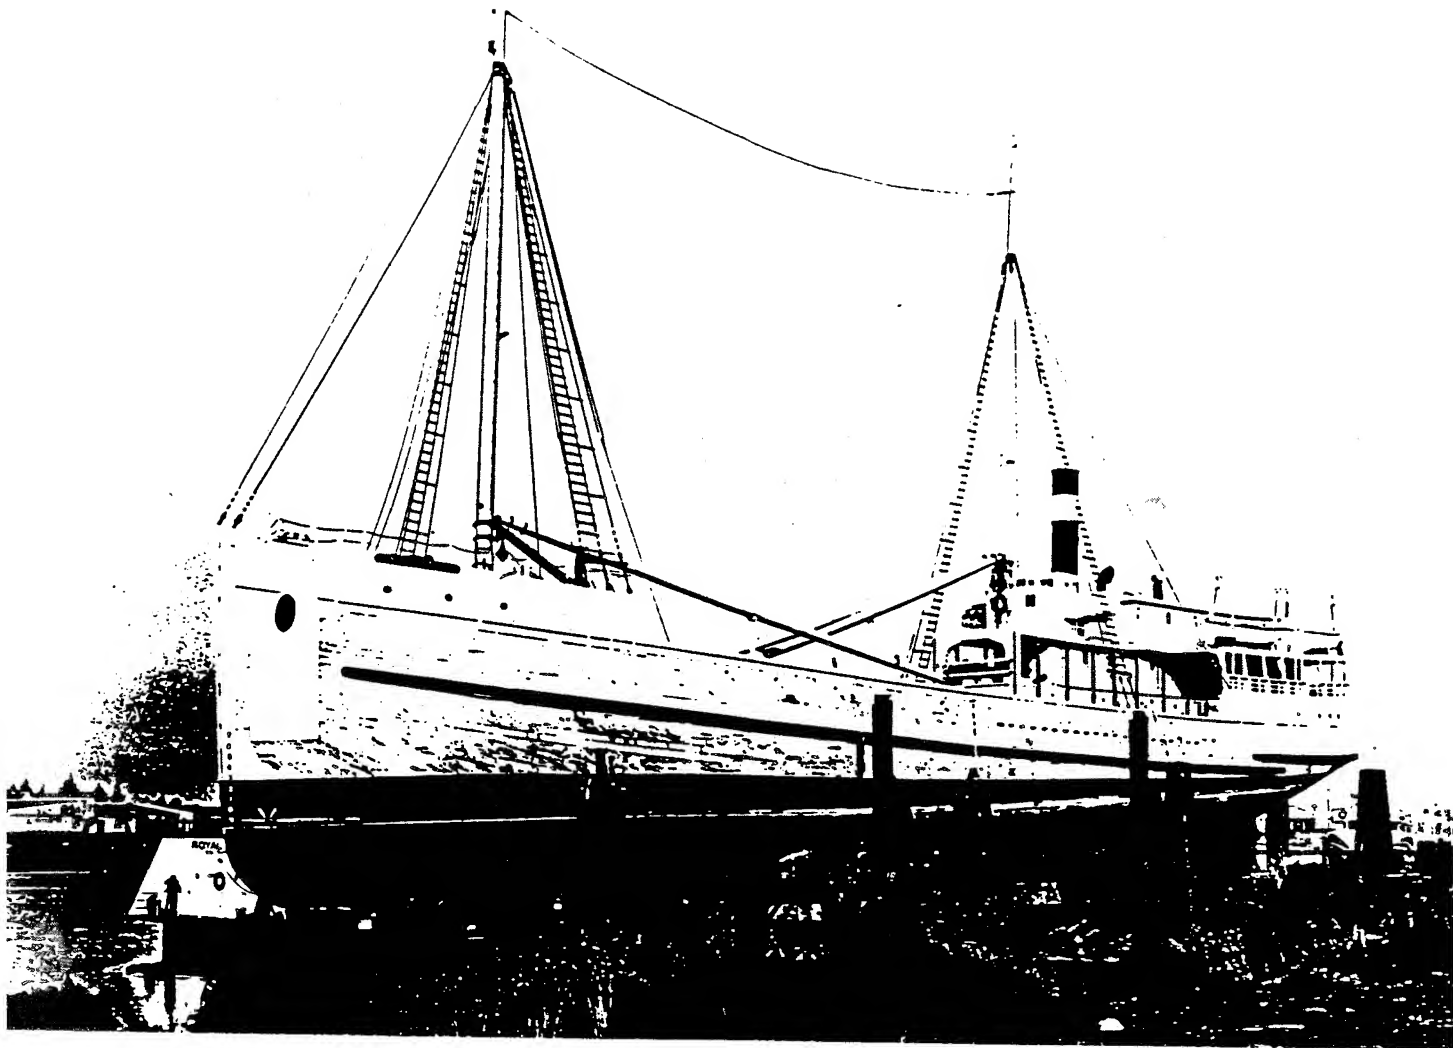
Fig. 42. WAPAMA on Barge 214 in 1980. This photo gives a good idea of the area of underwater hull relative to exposed decks and topsides. The badly weathered and rotten topside planking is visible, but the deckhouses still appear in fair condition. The masts and booms have not yet been removed and the slack in the spring stay may be indicative of the degree of hog that settled out when she was drydocked. --Photo, NMMSF

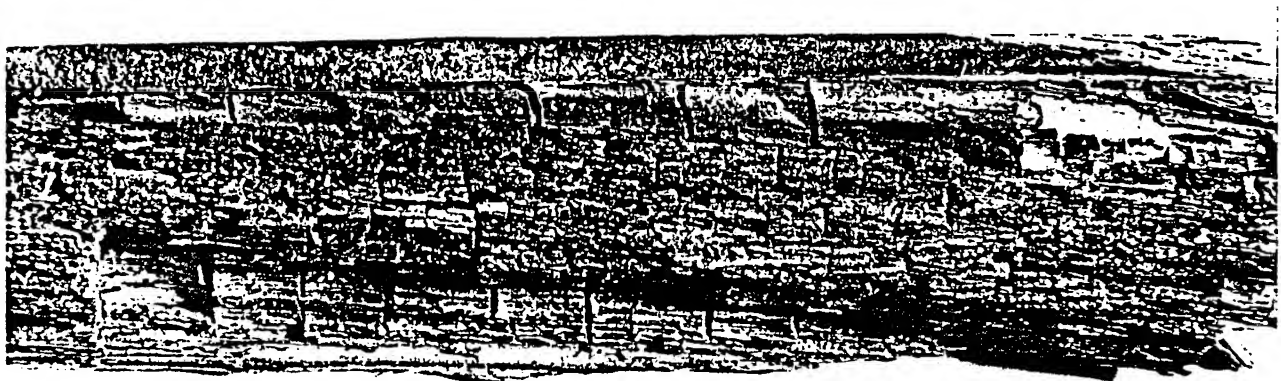
Fig. 46. Typical occurrence of brown rot decay. Sample section from covering board, port side of main deck. TCM

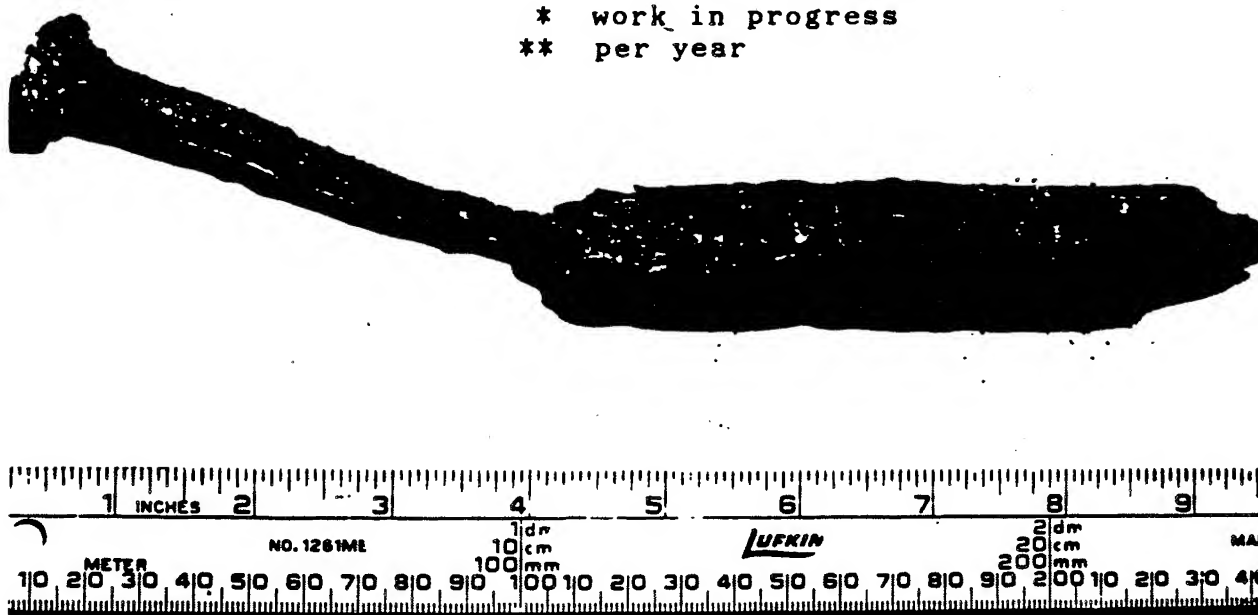
Fig. 47. Corroded iron spike plank fastening, taken from topsides, port side, frame 45, strake 22. --Photo, TCM

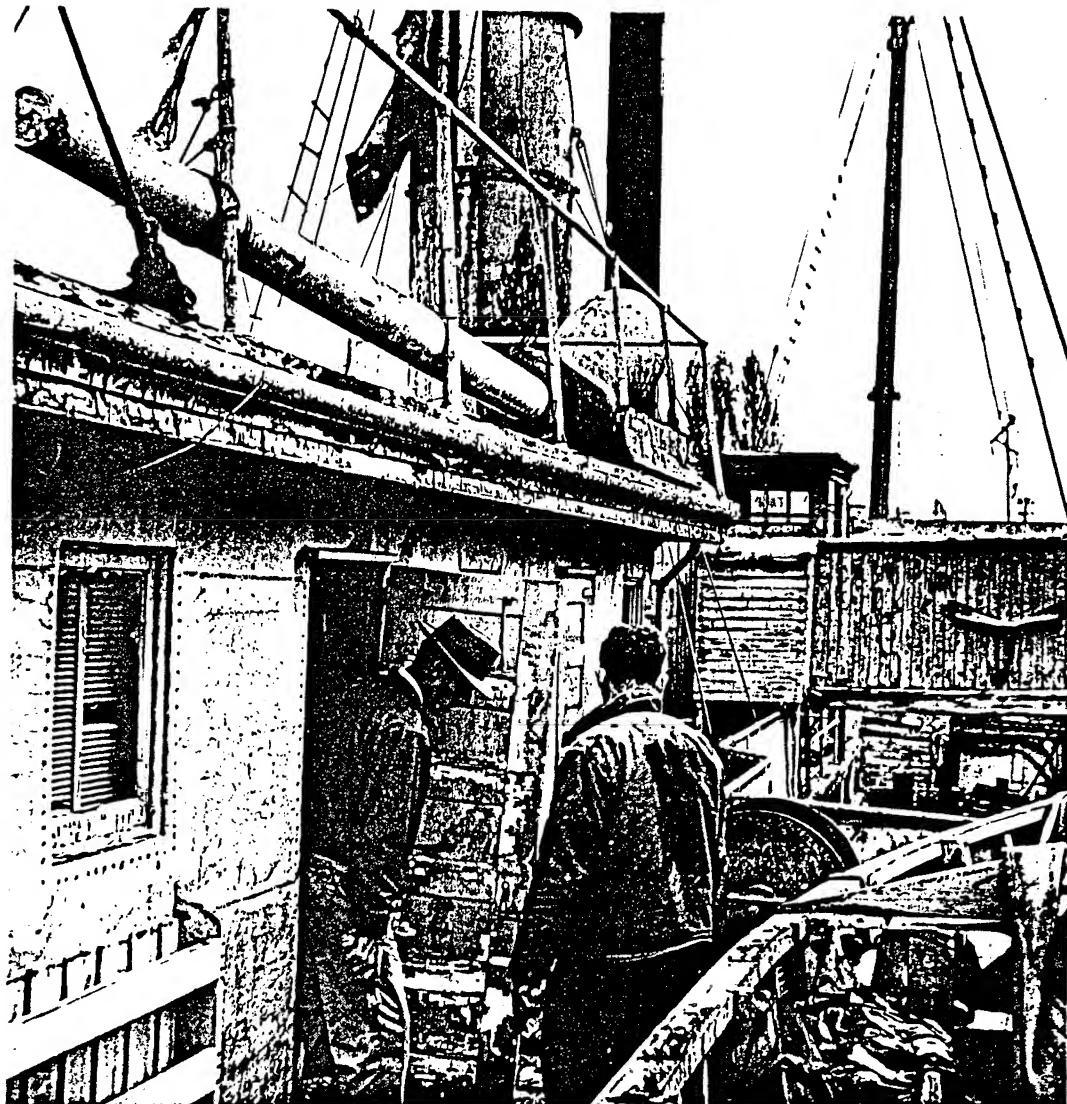
Fig. 54. WAPAMA in the 1950s, before initial restoration had begun. The canvas tacked over the deck house siding bespeaks an attempt to deal with rot and leaks that were present before she was laid up in 1947. The effects of years of lay up with no maintenance are plainly visible. The deck house had to be completely rebuilt in 1960.

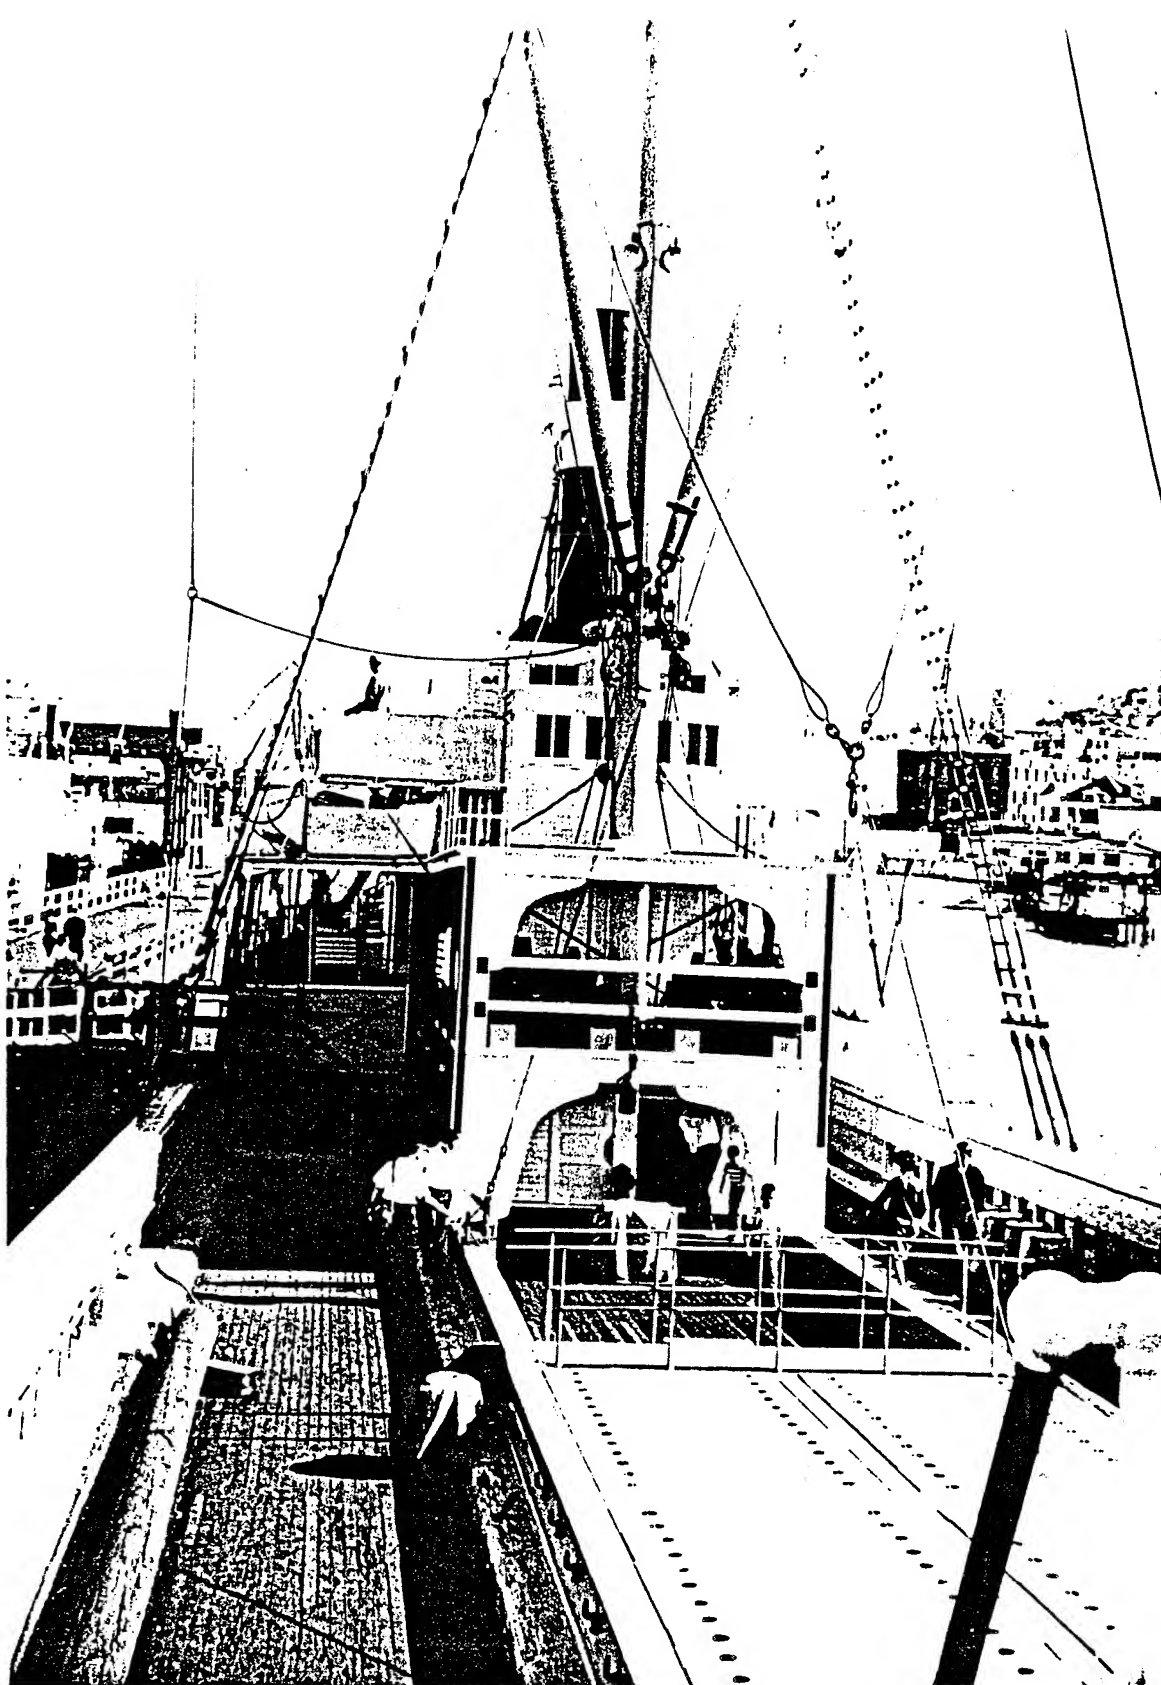
Fig. 55. Wapama in the 1960s. Her rigging is in place and functioning; she is well interpreted, and has a glistening coat of paint. She has undergone considerable restoration, but deterioration is here evident in her main deck. Rot is progressing.
